## UNBURNT COAL IN THE MARINE ENVIRONMENT

A decade ago, the IMO review of bulk carrier safety noted many structural risks facing such vessels. Safety expert Dennis Barber says it is time to review the stresses and strains that bulk carrier hulls still face

# Bunker spill risk

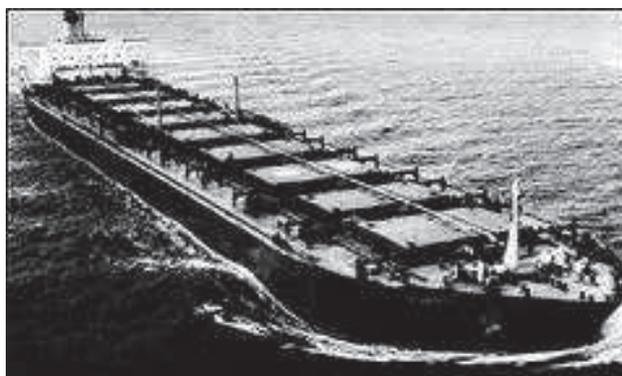
'Derbyshire', lost with all crew in a typhoon

In the list above the causes of failures were not fully understood. Research into hatch cover failure was, until seafarer input was sought and incorporated, preoccupied with vertical forces. The evidence from the 1980 sinking of Derbyshire suggested that the hatches collapsed under weight of water. This may have been the case and it was officially acknowledged as such, but it was far more likely that the failure of hatches and air pipes came initially from the forward side of the hatch, not from above. Large waves overtopping the forward end would have enormous momentum that would have been capable of dislodging the hatch covers and shearing off the air pipes exposed to the rush of water across the relatively unimpeded foredeck.

Examination of hatch covers that were found in the hold of the wreck suggests this was indeed the cause. The hatch cover skirt was torn out horizontally, indicating that a large force struck it from ahead. Once dislodged, the cover would have been able to fall into the aperture of the forward hold that previously it had been protecting. It is probable that it would also have been exposed to the huge mass of water bearing down on it from above, and this, together with its own weight, would have projected it into the hold.

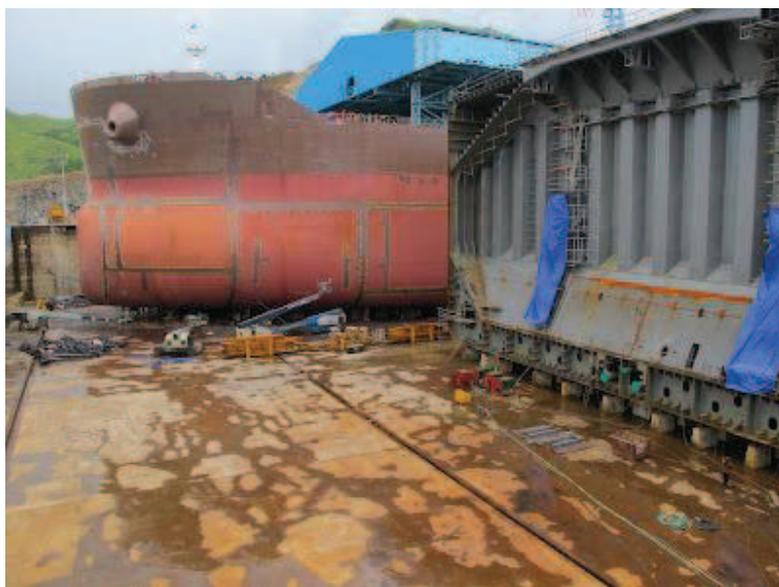
Forecastle adds reserve buoyancy

A forecastle offers not only protection to the forward parts of the vessel (and incidentally to seafarers on deck) thus preventing the type of damage to forward hatches referred to above, but also provides valuable reserve buoyancy. The lack of forward reserve buoyancy was also identified in a study submitted by the China delegation at the IMO in 2001 looking at possible deficiencies in the International Convention on Loadlines. The IMO was alerted to the findings at the time of the FSA.

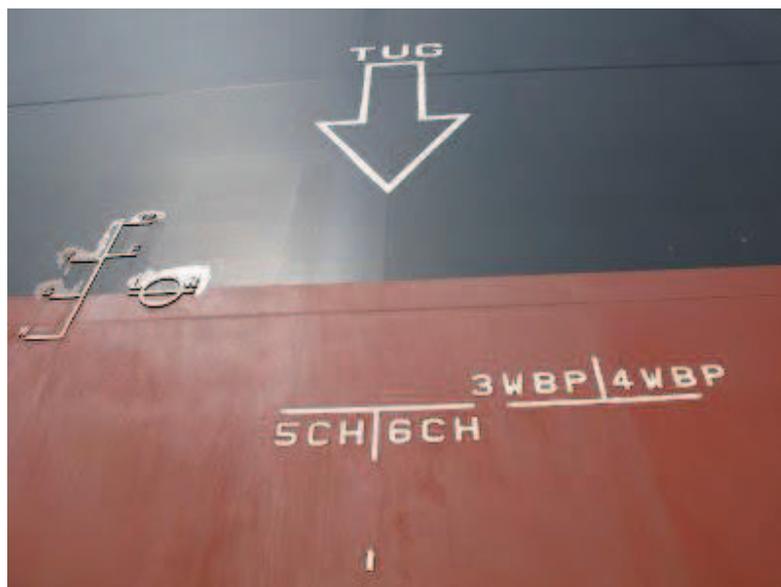
Tug push marks aligned with cargo hold bulkheads

Modern mariners will be familiar with the marks on the sides of large vessels. The tug pushing points are an admission that the side is not strong enough to resist the force imposed by a tug unless it coincides with a bulkhead. The professionalism of tug masters is thus the main mitigation against damage in this area. In the vast majority of cases, they get it right.
